A NIKE FAILURE STUDY

X-721-66-98

by
Abrom Hisler

March 1966

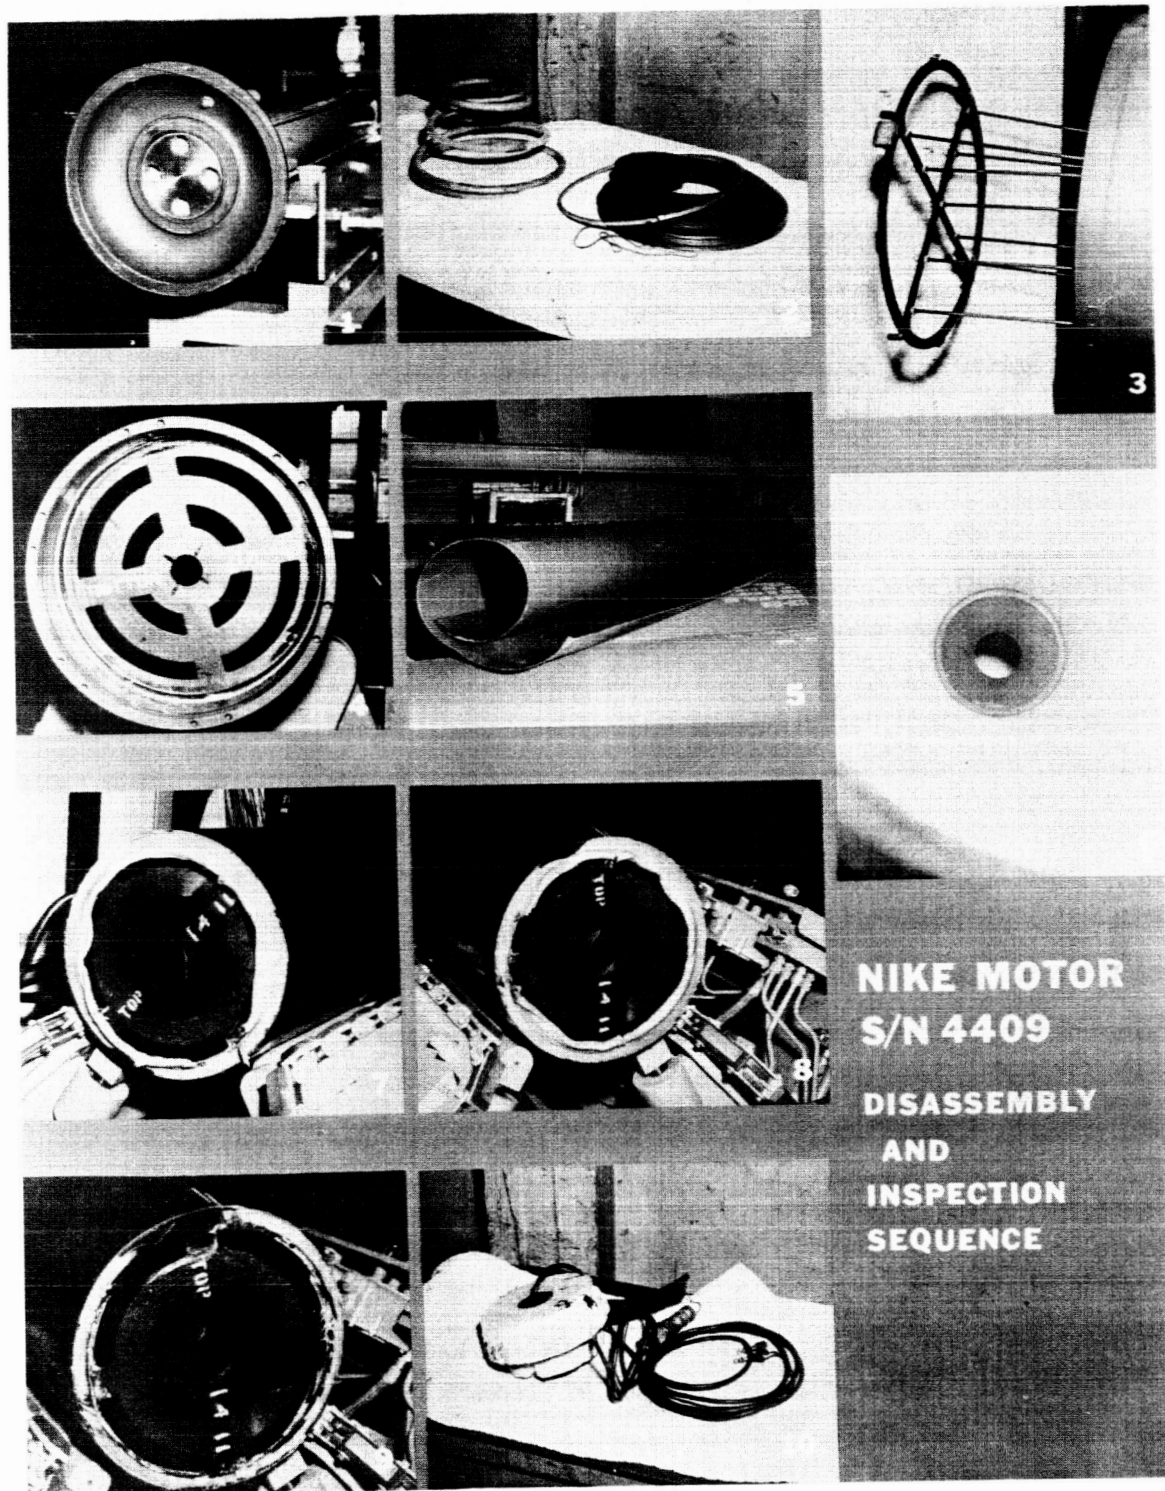
Figure 1

Upon disassembly and inspection of the S/N 44099 unit, the following discrepancies and possible indications of modes of failure were noted:

1. three inadequately torqued resonance rods; they were not finger-tight
2. grain undercut at the forward end: possibly reducing the structural integrity of the grain near burnout
3. poorly applied sealing compound at the aft end of the grain (in the 11:00 position of Figure 1): possibly permitting leakage (and flow) of otherwise stationary hot gases to the aft end of the motor along the insulation coated metal wall.

The composite photograph, Figure 1, may help to show the various stages of disassembly of the S/N 44099 unit along with the noted discrepancies. Sequentially

it shows the forward head as removed (photo #1), then the removal of the shipping plug (replaced by the igniter prior to firing), the snap ring, and the spring which immobilizes the propellant grain (photo #2), the resonance rod assembly partially withdrawn from the grain (photo #3), the undercut forward end of the grain (photo #4), the template paper to protect the flamastic coating during grain loading and conveniently slide the propellant grain into the chamber case (photo #5), views of the sealing compound, as found, applied to the aft end of the grain (photos #7 and #8), a portion of the sealing compound removed to determine whether the uncham-fired chill ring had cut into the aft end of the grain* (photo 9), and the nozzle closure with electrical harness (photo #10).

As a result of this disassembly and inspection, it was found necessary to update the quality control for the resonance rod assembly to:

1. Replace the now obsolete rubber grommet specification with that for the Belleville springs.
2. Properly torque the nuts of Ordnance Corps Drawing 8025087 so that the Belleville springs are under adequate compression.
